## Technical Director Report

### Crash of N°39 Luis Salom during Moto2 FP2 of the Catalunya GP.

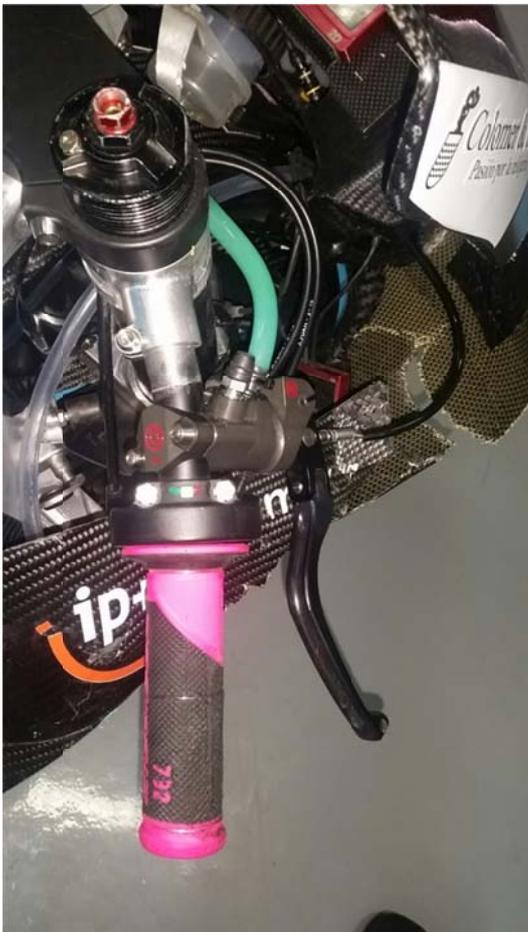
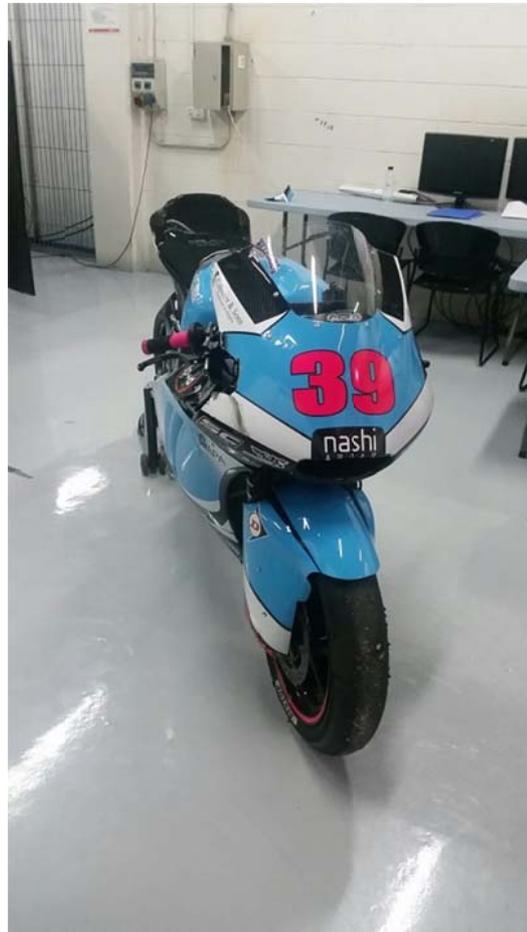
Immediately after the crash, the motorcycle of Luis Salom was delivered directly to the Technical Bay located in Pit Box 1. During an inspection of the motorcycle it was noticed that the “throttle” handlebar was loose and could easily be removed from the clamp that connects it to the fork leg. It is likely that this could be as a result of the crash.

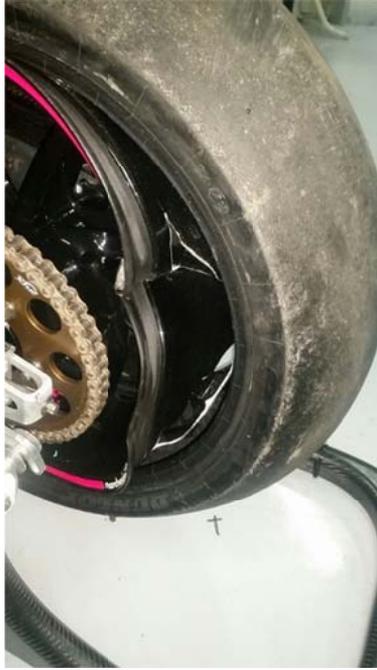
The rear wheel had extensive damage, resulting in one part collapsing in on itself. This type of damage is common when the wheel impacts with a solid object after a high speed crash. There is no evidence that the wheel was faulty or in any way caused the accident.

Front and rear tyres were inspected and were in good condition with the front tyre still inflated. The data showed the rear tyre pressure was at the recommended pressure of 1.4bar at the time of the incident. This confirms that the rear rim failure is a consequence of, and not a cause, of the accident.

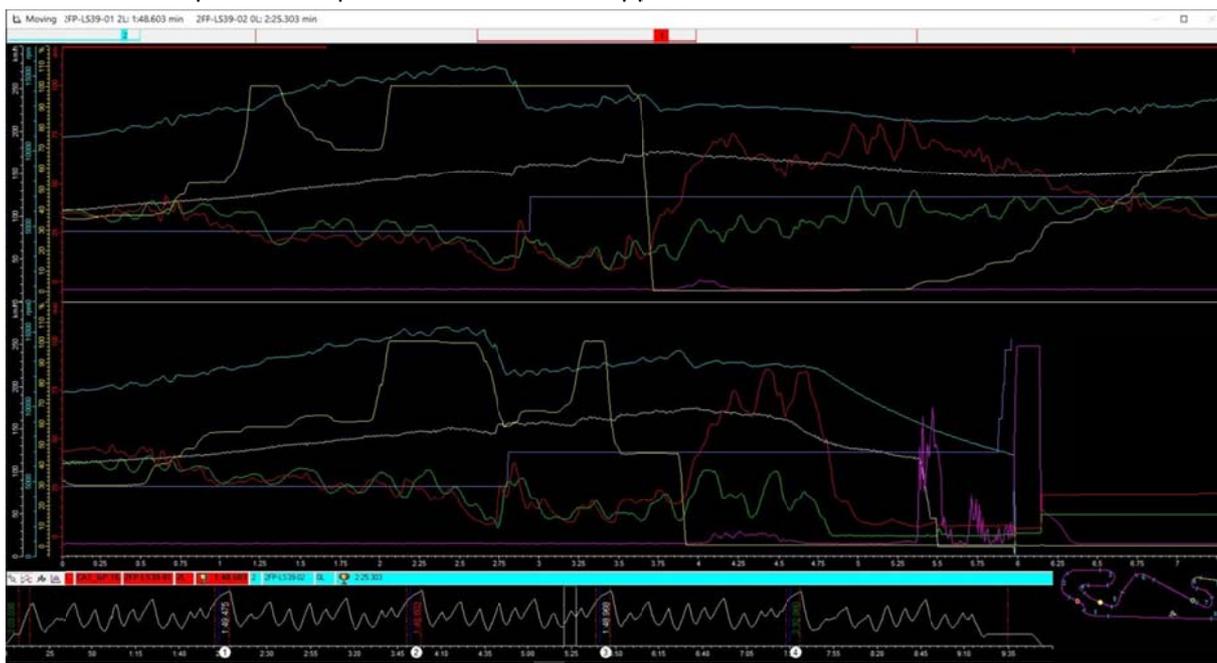
The upper part of the graphic is from a previous lap at turn 12.

The lower part of the graphic is the data from the crash into turn 12.

The upper graphic throttle data (In yellow) shows a typically normal throttle closing just prior to applying brake pressure before corner entry.

The lower graphic throttle data looks uncommon because instead of completely closing it shows the throttle partly closing to approximately 45% for a period of around 0.3 seconds before fully closing.

After the throttle is fully closed, brake pressure (In pink) is applied.

The larger movements in the front and rear suspension (Red & Green respectively) during braking on the lower graphic, after the throttle is closed, show instability of the bike just before the front speed reduces quickly indicating loss of control of the front of the bike resulting in a crash.

Confirming the initial analysis Mr. Gomez reported that his data showed that at the time of the accident the bike was 4 Km slower than its fastest lap but at the time of braking the rider was 7 or 8 meters closer to the curve than on his fastest lap. He confirmed that on the piece of straight between the two curves, there was a partial cut in the throttle.

Mr. Gomez speculated that the rider may have looked back and when returning to look forward misread his position, or was a little off line. This could have resulted in higher than usual brake pressure being applied, which was indicated on the telemetry. As a result of being off line and the braking with the machine being banked the front wheel lost traction resulting in the crash.

Mr Gomez confirmed that he could not see anything unusual that he felt was of any concern. He also confirmed that there was no evidence in the data that raised issue with the track surface including possible bumps.
